**CARR FORK LAKE**  
**KENTUCKY RIVER BASIN**  
**KENTUCKY**

**EMBANKMENT CRITERIA AND  
PERFORMANCE REPORT**

**PREPARED BY**  
**U. S. ARMY ENGINEER DISTRICT, LOUISVILLE**  
**CORPS OF ENGINEERS**

**SEPTEMBER 1982**

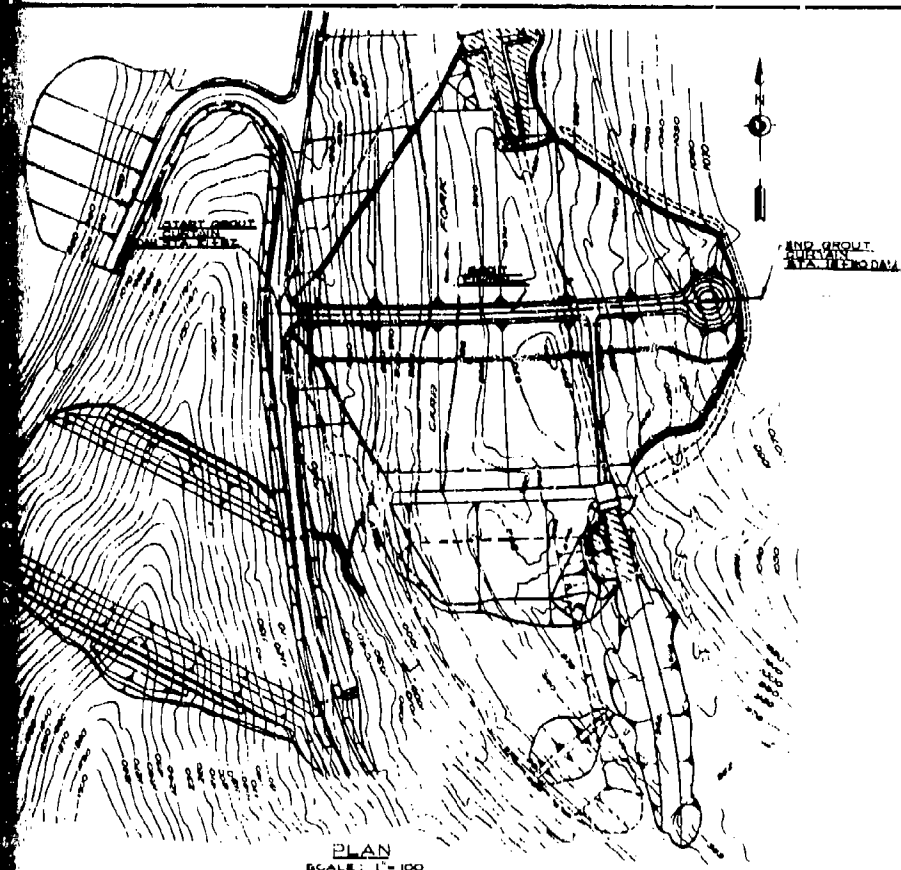
There were very few problems encountered during grouting. There were various joints encountered within the core trench in the embankment foundation and on the left abutment. These joints were cleaned out to a depth 3 times their width. They were then filled with a special non-shrinking, quick setting grout. There were seven coal beds exposed in the core trench. All of these received dental treatment, either concrete or mortar. On the left abutment, there were four coal beds; one at elevation 980.0 to 980.3, cleaned out 1 foot in depth and filled with mortar the width of the core trench; two at elevation 1025.3 to 1026.3 and 1027.5 to 1028.0 with a shale layer between them. These two coal beds were cleaned out altogether, along with the shale layer, the width of the core trench, 1-foot deep, and filled with concrete. One coal seam at elevation 1056.7 to 1056.9 along with 0.7 foot of underclay was cleaned out 1 foot in depth and filled with concrete. On the right abutment there were three coal seams; one at elevation 988.5 to 988.7 cleaned out, 1-foot deep, the width of the core trench, and filled with mortar; two beds from elevation 1048.1 to 1049.6 with a shale layer between them from 1048.5 to 1049.2 were cleaned out the width of the core trench, 1-foot deep and filled with concrete. During an optional 50-foot widening of the left wall of the spillway to obtain more rock for the embankment construction, 5 mine rooms were encountered during presplitting operations. These rooms are in the Hazard #4 coal seam from elevation 1120 to 1124. These openings were sealed with concrete to prevent any further deterioration, and to prevent entry by visitors. 1415 cubic yards of concrete was used. The foundation treatment is shown on Plate 8.

1. ALL LOOSE WEATHERED ROCK ON FOUNDATION AND ABUTMENTS WITHIN LIMITS OF IMPERVIOUS EARTH CORE SHALL BE REMOVED PRIOR TO SLUSH GROUTING.
2. ALL VERTICAL ROCK EXPOSURES OVER 2' IN HEIGHT AND ALL ROCK OVER-HANGING LEDGES WITHIN LIMITS OF THE IMPERVIOUS CORE SHALL BE EXCAVATED TO A MAXIMUM SLOPE OF 4V ON 1H PRIOR TO SLUSH GROUTING.

4. FILLING OF CRACKS OR FISSURES WITHIN THE SPECIAL TREATMENT AREA AND FOUNDATION AREA SHALL BE WITH SLUSH GROUT, BUT LIMITED TO THE OPENINGS IN THE ROCK SURFACE, AND THIN LAYERS OF SLUSH GROUT SHALL NOT COVER SURFACE AREAS OF SOUND ROCK WHERE IT MIGHT CRACK OFF UNDER ROLLING ACTION.

7. THE COAL AND ASSOCIATED UNDERGLYAN BEARING IN THE ABUTMENTS UNDER THE IMPERVIOUS CORE OF THE EMBANKMENT SHALL BE REMOVED TO A MINIMUM DEPTH OF ONE FOOT AND REFILLED WITH CONCRETE.

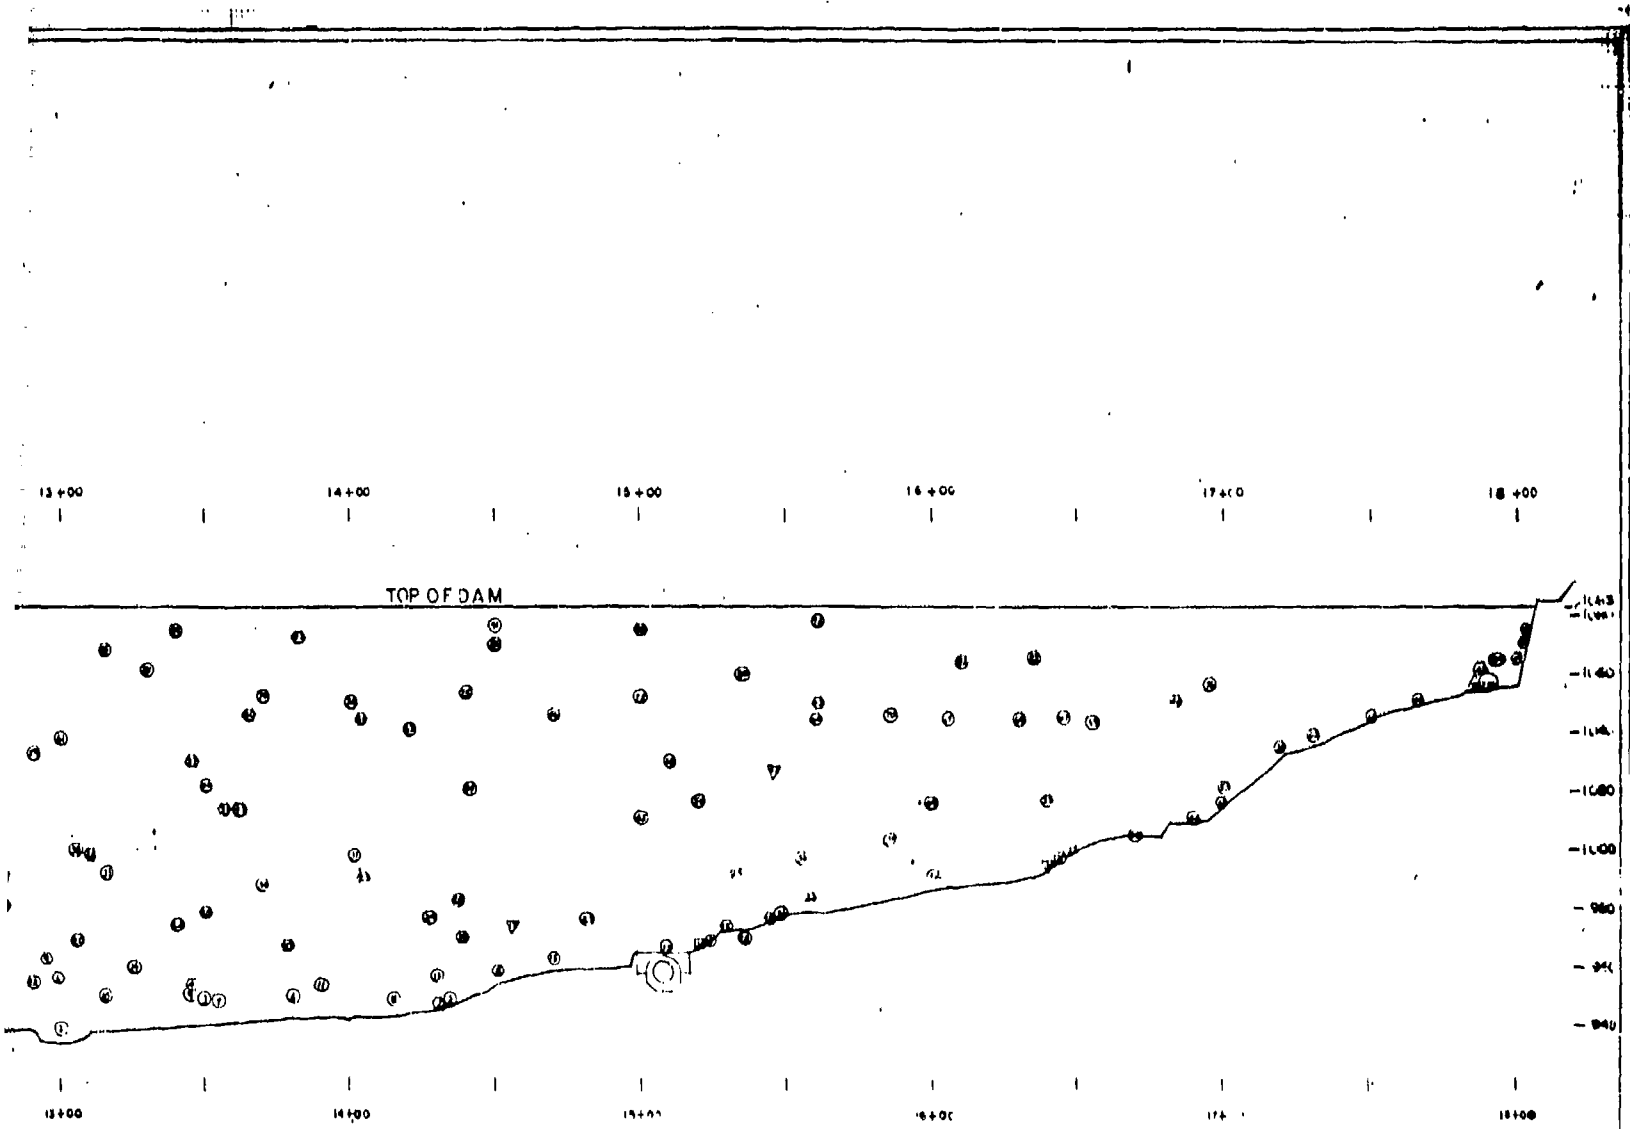
PLATE 19 2

\* OF THE 89 TESTS RUN ON THE IMPERVIOUS MATERIAL 7 TESTS WERE AT OPTIMUM AND 4 TESTS INDICATED THE MATERIAL WAS BELOW THE OPTIMUM. 3 TESTS FAILED WERE REWORKED. ALL AREAS WERE RETESTED AND THE RESULTS WERE RECORDED.

\*\* OF THE 29 TESTS RUN ON THE RANDOM MATERIAL ONLY 1 TEST FAILED (BELOW THE COMPACTION DESIRED). THIS AREA WAS REWORKED AND RETESTED.

\*\*\* OF THE 20 TESTS RUN ON THE TRANSITION MATERIAL ONLY 1 TEST FAILED (BELOW THE COMPACTION DESIRED). THIS AREA WAS REWORKED AND RETESTED AND THE RESULTS WERE RECORDED.

\* OF THE 53 TESTS RUN ON THE IMPERVIOUS MATERIAL 3 TESTS WERE AT OPTIMUM AND 2 TESTS INDICATED THE MATERIAL WAS BELOW THE OPTIMUM. 1 TEST FAILED WERE REWORKED. THERE WAS 1 AREA THAT WAS REWORKED.

\*\* OF THE 8 TESTS RUN ON THE RANDOM MATERIAL 0 TESTS FAILED.

\*\*\* OF THE 11 TESTS RUN ON THE TRANSITION MATERIAL 0 TESTS FAILED.
